**City of Sisters
Creekside Park and Campground
Master Plan
December 10, 2015**

Creekside Park and Creekside Campground

Date: July 29, 2015
To: Patrick Davenport, AICP
From: Scott Beaird, PE
Project: City of Sisters On-Call Services
Subject: Creekside Campground Access Evaluation

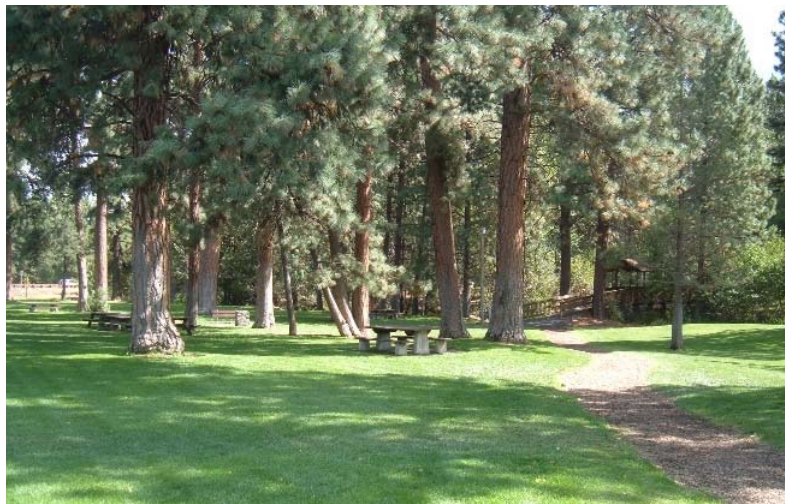
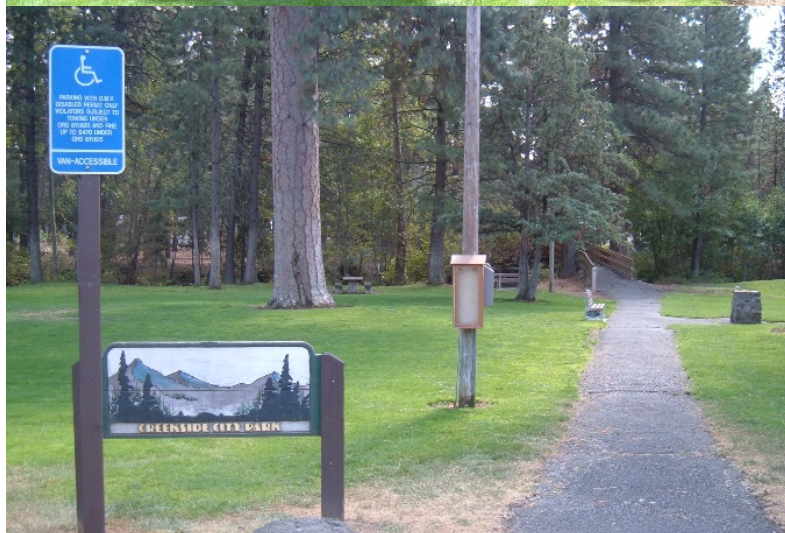
Figures 5 and 6. Photos of Day Use Side

- Signage
- Information/directional signage
- Parking
- Creek Access
- Bike and Pedestrian Bridge
- Picnic Tables (10)
- Benches (1)
- Dog Station (1)
- Drinking Fountain (1)
- Trees and Landscaping
- Restrooms are accessible via a pedestrian footbridge that spans Whychus Creek.

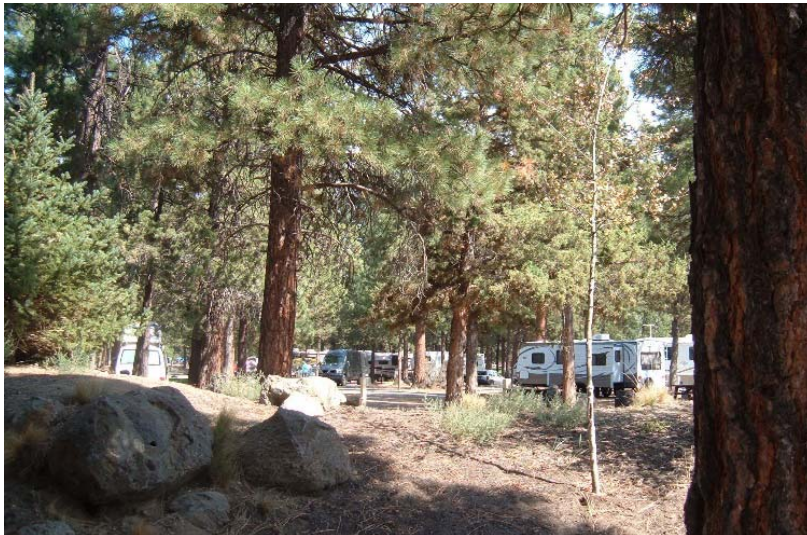
Figures 7 and 8. Photos of Campground Side

- Camping Full hook up – 30 amp: (20)
- Camping Full hook up – 50 amp: (5)
- Non hook up /tent sites – (42)
- RV Sewage Disposal Station
- Storage Sheds (3)
- Camp Host Site
- Fire Pits for Each Campsite
- Pay Station
- Picnic Table for each campsite
- Trash Dumpster (1)
- Signage
- Access to Whychus Creek Trail and Covered Footbridge
- Access to Whychus Creek
- Restrooms
- Two showers
- Walk-in hiker/biker site

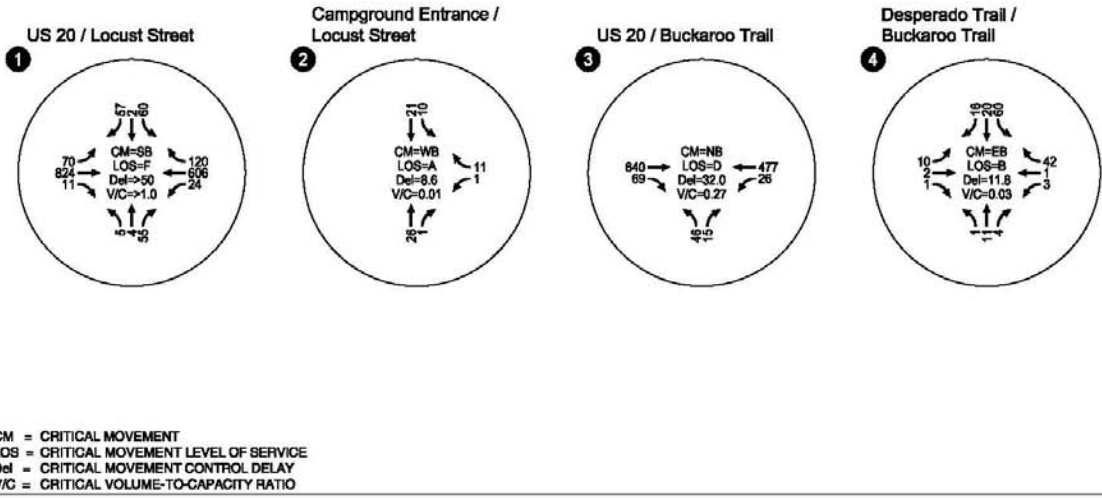
**Figure
2**

The observed peak hour turning movement counts were evaluated with the lane configurations and traffic control shown in Figure 1. Figure 2 summarizes the resulting intersection operational analysis¹. As shown in Figure 2, each of the study intersections, with the exception of US 20/Locust Street, operate under capacity and with acceptable level of service (LOS). Demand at the US 20/Locust Street intersection exceeds capacity and operates at LOS F during the weekday afternoon peak period.

**Existing Weekday PM Peak Hour Traffic Conditions
Sisters, Oregon**

- The US 20/Locust Street intersection currently operates over capacity and with LOS F. This condition will continue regardless of the access scenario for the campground.

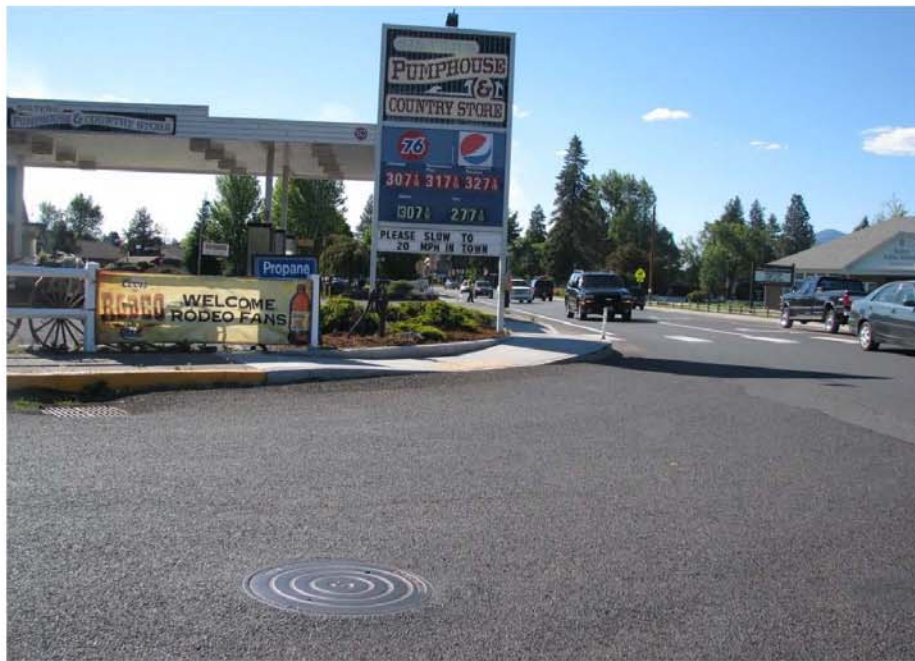
At the US 20/Locust Street intersection, sight distance was measured for the northbound Locust Street movement. As identified in Table 2, the posted speed for US 20 at this intersection is 20 miles per hour (mph). According to AASHTO, the minimum sight distance at 20 mph is 225 feet for the left-turn movement (Case B1) and 195 feet for the right-turn movement (Case B2). The available sight distance for both the left-turn and right-turn movements at the US20/Locust Street intersection exceeds the minimum distance identified in AASHTO.

While the available sight distance exceeds the minimum required sight distance for a driver eye height of 3.5 feet, the sign for the fuel station in the southwest quadrant of the intersection, shown in Exhibit 3, may limit the available sight distance for drivers in vehicles that sit higher, such as recreational vehicles. These drivers may be required to move forward towards the travel lane and beyond the stop bar to have adequate visibility of oncoming traffic.

Exhibit 3. Sight Distance for Vehicles Turning Right from Locust Street to US 20

- The sign in the southwest quadrant of the US 20/Locust Street intersection potentially limits sight distance for taller vehicles.
 - *Recommendation: The City should consider whether restriping the northbound stop bar in a location closer to the travel lane would improve the sight distance for taller vehicles.*

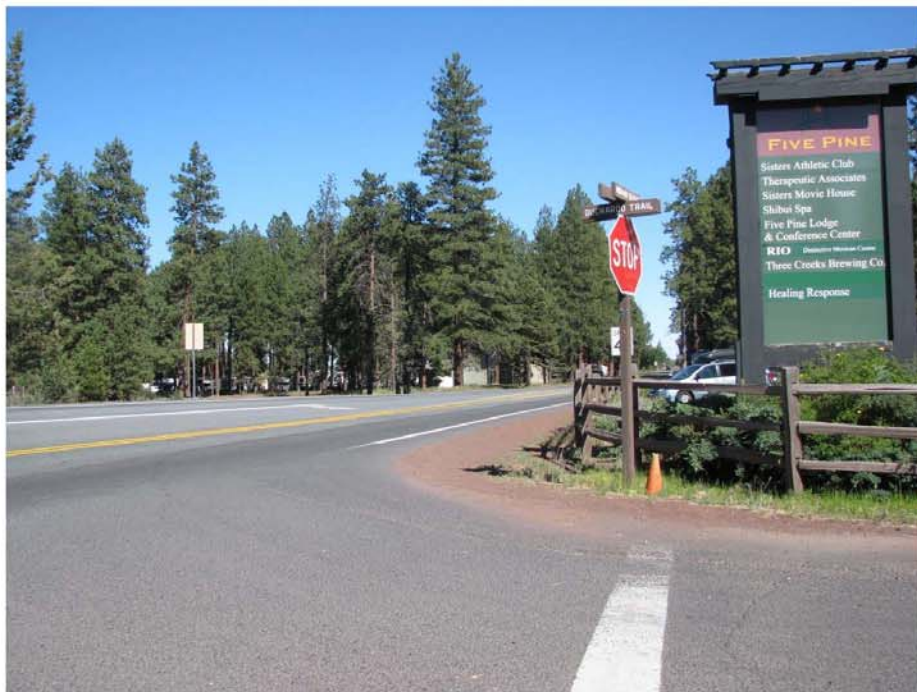
At the US 20/Buckaroo Trail intersection, sight distance was measured for the northbound Buckaroo Trail movement. As identified in Table 2, the posted speed for US 20 at this intersection is 45 mph to the east and 35 mph to the west. According to AASHTO, the minimum sight distance at 45 mph is 500

feet for the left-turn movement (Case B1). The minimum sight distance at 35 mph is 335 feet for the right-turn movement (Case B2).

The available sight distance to the west (Case B2) exceeds the minimum of 335 feet. However, the sight distance to the east (Case B1) is limited by the fence and sign in the southeast quadrant of the intersection, as shown in Exhibit 4. The available sight distance to the east is approximately 230 feet. To gain adequate sight distance to the east, drivers are required to move forward past the stop bar.

Exhibit 4. Sight Distance for Vehicles Turning Left from Buckaroo Trail to US 20

- The fence and sign in the southeast quadrant of the US 20/Buckaroo Trail intersection restricts sight distance to less than the minimum required sight distance.

- Option 1 would add additional traffic to this movement, while Option 2 would reduce traffic making this movement
 - *Recommendation: Regardless of the access option selected, the City should work with ODOT to determine whether restriping the stop bar in a location closer to the travel lane would improve the sight distance at this intersection or whether the fence and sign can be relocated.*
