Creekside Park Restoration Project – Conceptual Design Report

City of Sisters and Upper Deschutes Watershed Council

August 29, 2018

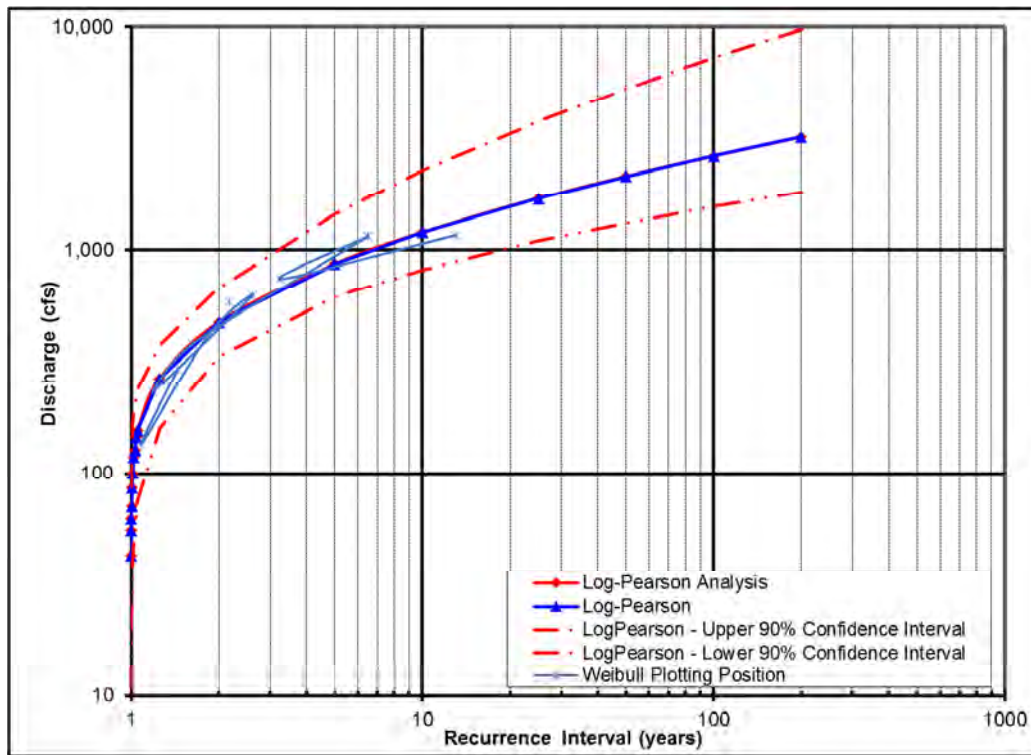
Figure 1: Flood Frequency Analysis (Log-Pearson Type III) of Whychus Creek at Upstream Locust Street Crossing

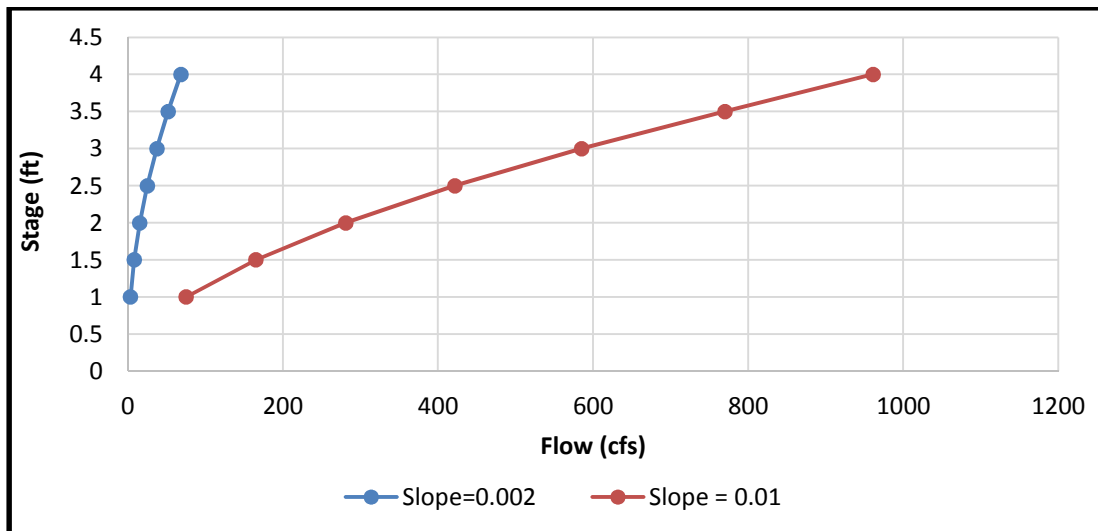
Figure 3: Win XSPRO Output Data for Modeled Cross Section of Whychus Creek, 150 Feet Downstream of Historical Footbridge

Figure 3 depicts the WIN XSPRO output data for the modeled cross section within the project’s reach of Whychus Creek. Stream slopes of 0.2% (blue) and 1% (red) were both utilized in modeling the cross section with WIN XSPRO. The actual stream slope is about 1%. As a sensitivity check, both stage-discharge curves are shown.

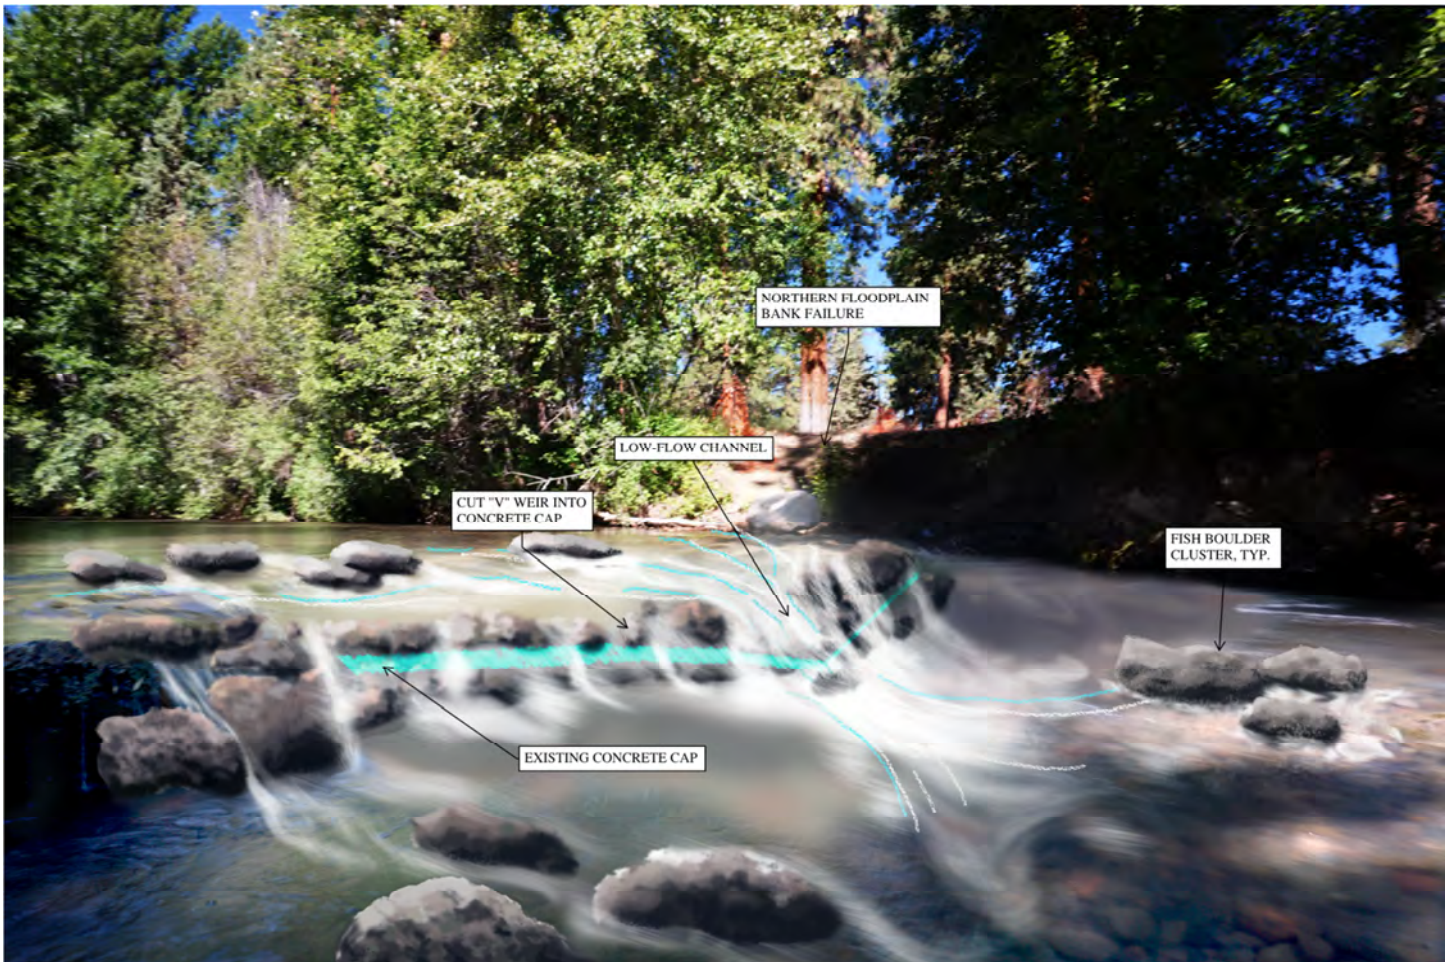
Figure 4: Photo Rendering (C. Schenider) of Example V-Shaped Notch Weir along In-Stream Concrete Cap

Partially removing the concrete cap by creating a V-shaped notch will be the most cost and time efficient option. All design alternatives, except for #3 and #5 will have exposed concrete, unless otherwise covered. As previously mentioned, fish boulders or large rock can be placed around and buried into the streambed to provide a more natural looking aesthetic. Creating a backwater effect to raise the water level downstream of the cap would require a series of low rock weirs. Elevation change between each step should not exceed 6 inches for fish passage requirements and structural stability. Depending on the existing conditions, the Hwy 20 Bridge may located be too close to the concrete cap to allow for this design option. Alternatively, developing a fish rock ramp would also achieve this goal, but would require a large quantity of rock to slope the channel up to the concrete cap as well as to fill in the scour pool that has been created. Full replacement of the concrete cap could potentially also require replacing the 10-inch sewer line, at least between the existing access points. Design alternatives have been present graphically in the two Fish Passage and In-Stream Habitat plan sheets in Appendix A.

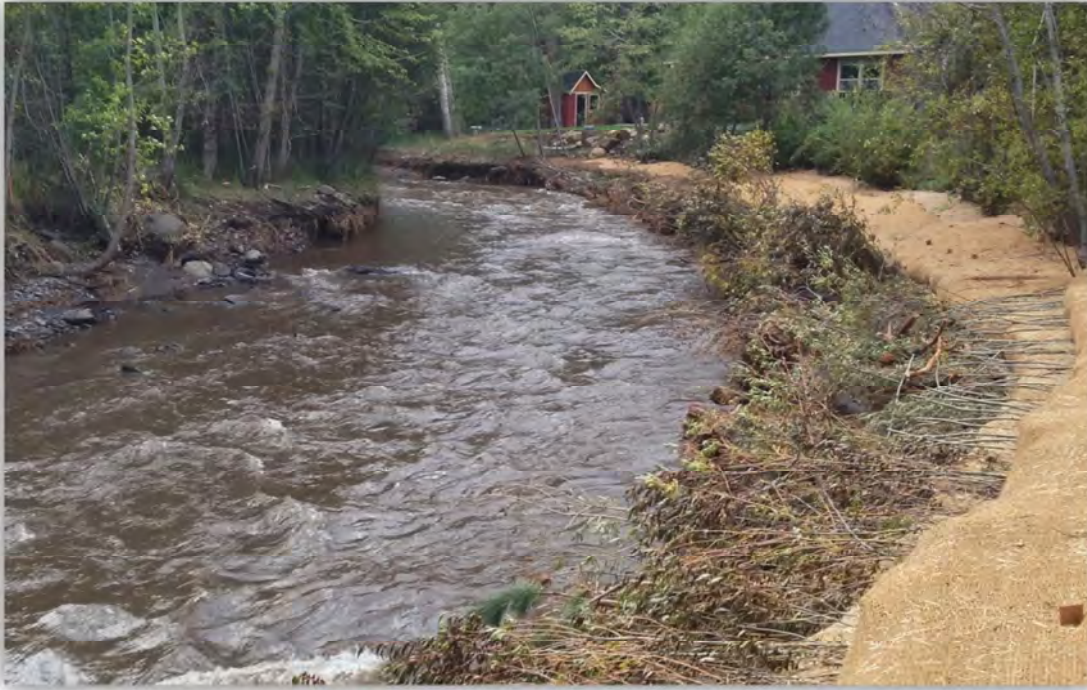
Figure 5: Example of a Bio-Engineered Soil Lift (Photo Taken Immediately Upon Completion)

Toe protection and stabilization of soil lifts can be designed with various materials. Depending on the local waterway regulations or preferred esthetics, rock, large wood, or other materials can be utilized to provide structural integrity. Creekside Park's project reach lacks in-stream diversity and aquatic habitat. Designing each additional soil lift with large woody material (salvaged during tree removal, if available) and/or rootwads would provide fish and aquatic species habitat to the reach. Additional bioengineering techniques can be incorporated into the soil lifts to provide beneficial habitat and nutrients to the creek, while maintaining its original purpose of restoring the failing banks. Examples of this include fish boulders, engineered large wood structures, laying back creek banks, and strategic native plantings. Size and quantity of the material will be dictated through further hydraulic modeling.

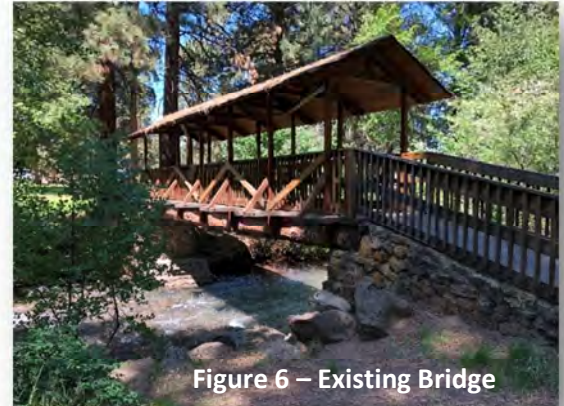
Figure 6 – Existing Bridge

Including its wood decking, roof structure, supporting logs, and rockery walls, this footbridge appears to be in good condition. However, the location of the abutments creates a constriction in the

active creek channel relative to the channel width upstream and downstream from the bridge. Hydraulic scour and undermining was observed beneath the north abutment, likely the result of accelerated flow velocities between the abutments. Current conditions do not appear to present an imminent danger to the stability of the bridge.

The bridge deck is approximately 4.5 feet above the adjacent ground on the north side and 3 feet above the adjacent ground on the south side of the bridge.

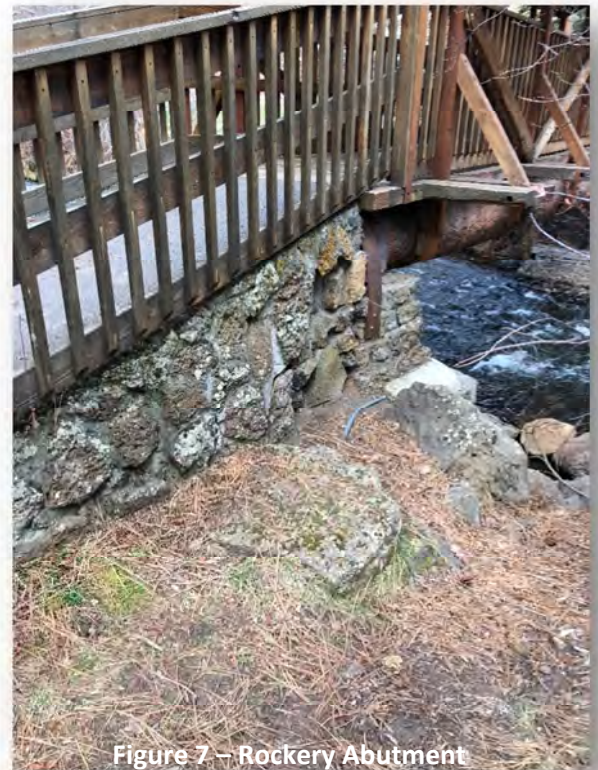
Figure 7 – Rockery Abutment

The bridge foundations, including the concrete footings, rockery abutments (see Figure 7), and approach ramps were reportedly constructed by the CCC in either 1939 or 1941. While the abutments and approach ramps are in good structural condition, they do not meet the ADA Standards for Accessible Design. Primary access issues include the steep slope of the approach ramps and lack of guardrails or handrails on the ramp. Replaced in the early 1990's, the bridge superstructure was reportedly and is also still in good condition.

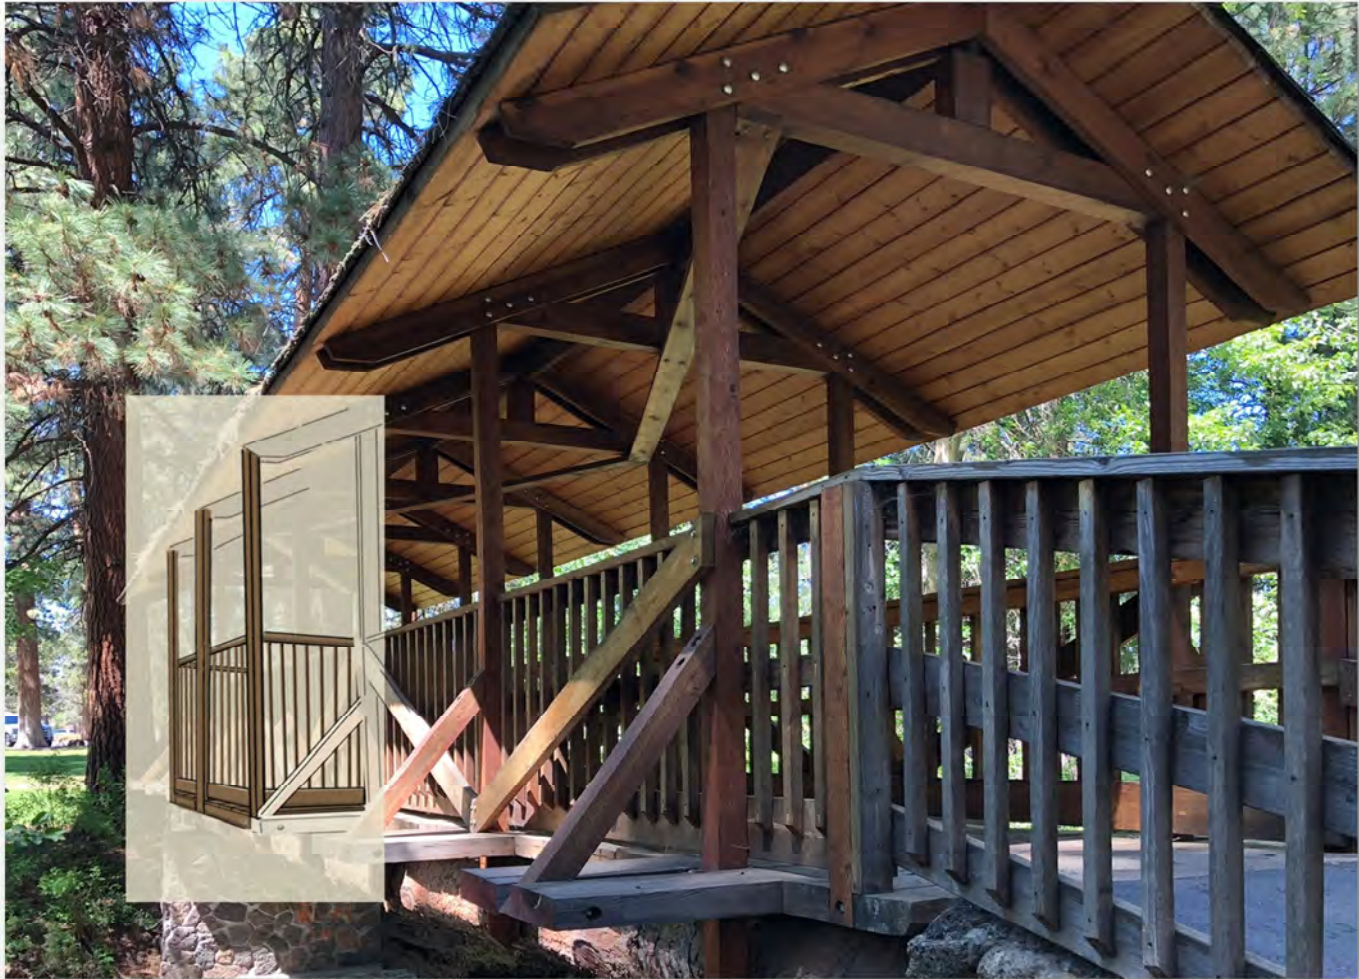
Figure 9: Photo Rending (C. Schenider) of Example Footbridge Bump-Out

In order to accommodate users who would like to pause on the bridge, the deck could be widened for one or two bays at mid-span of the bridge. By constructing a 2-foot wide 'bump-out' on the upstream and downstream edges of the bridge, it would allow users to step out of the primary traffic way and enjoy the views without impeding the traffic flow.

The bump-outs would be constructed of the same materials as the existing bridge (see Figure 9), including the same size structural decking, roof columns, and railing pickets to match the appearance of the existing bridge. Proposed locations along the existing footbridge can be seen in the Bump-out plan sheet in Appendix A.

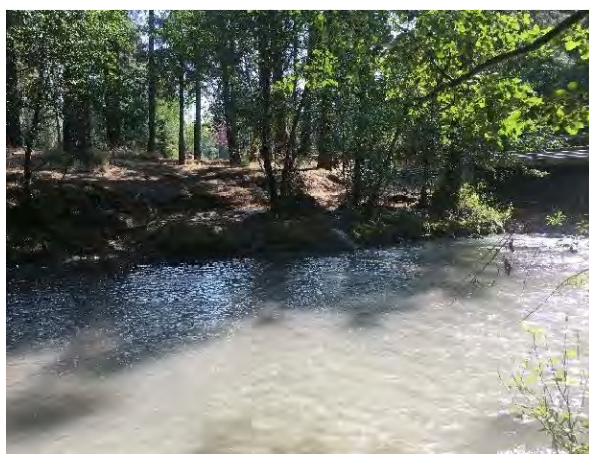
P1 BANK EROSION AND RIPARIAN ZONE DAMAGE

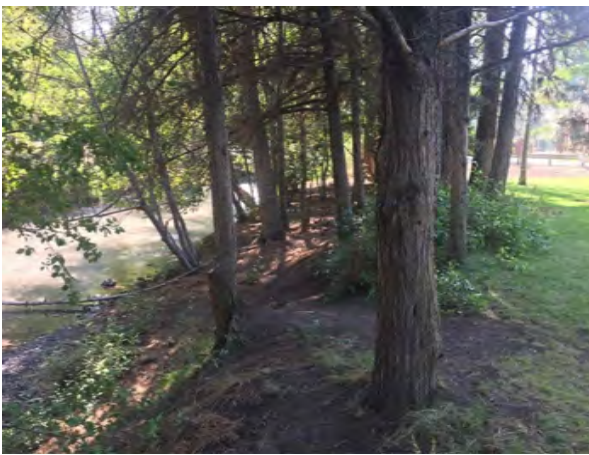
P2 USER-CREATED TRAIL AND ASSOCIATED BANK EROSION

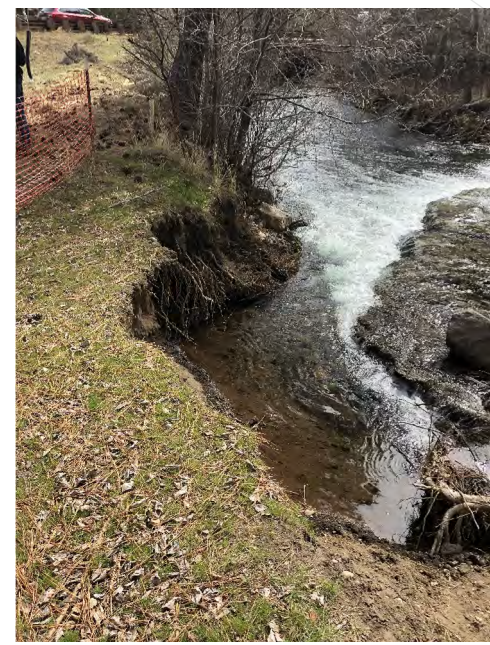
P3 BANK FAILURE ALONG NORTHERN FLOODPLAIN AT CONCRETE CAP

Beginning about five years ago, the northern streambank at the concrete cap began to fail. Park sprinklers, local turbulent creek flows, capillary action within the soil, and public access to the stream may have all exacerbated this failure. Currently, there is orange construction fencing protecting visitors from the eroded bank. Erosion, scour, and stream access has led the bank to begin to recede. Approximately 10 feet of bank recession has already occurred.

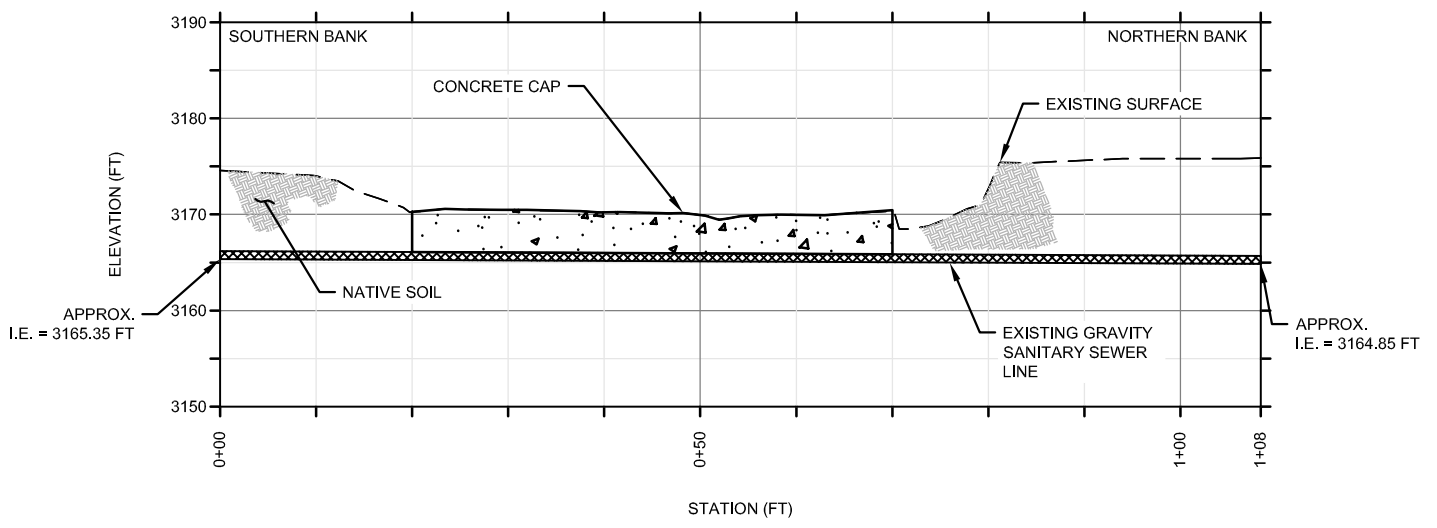
1 CONCRETE CAP - EXISTING CONDITIONS PROFILE
SHEET 2 NOT TO SCALE

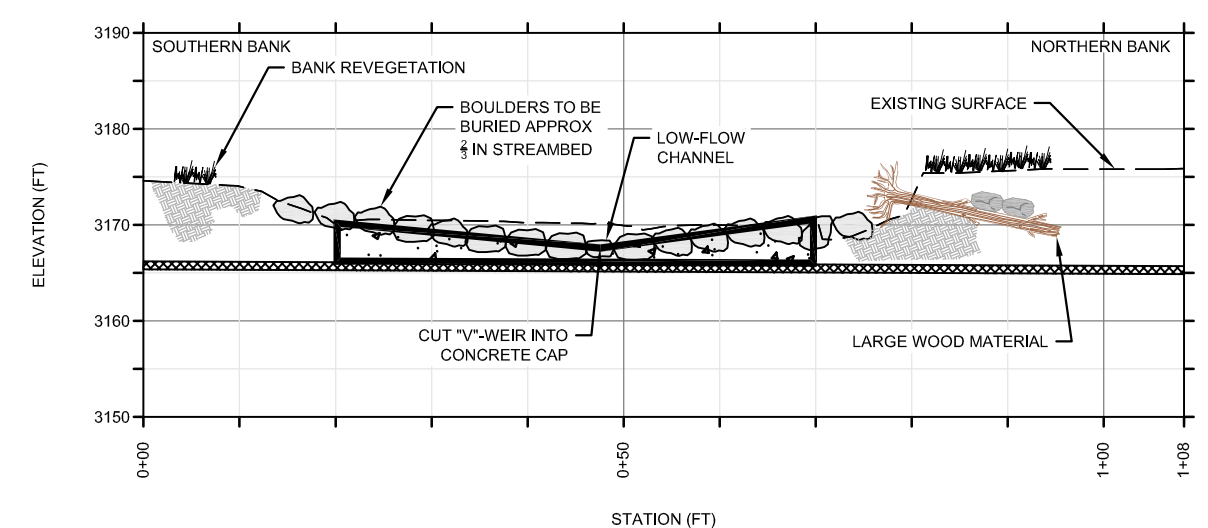
2 CONCRETE CAP - V-WEIR EXAMPLE PROFILE
SHEET 2 NOT TO SCALE

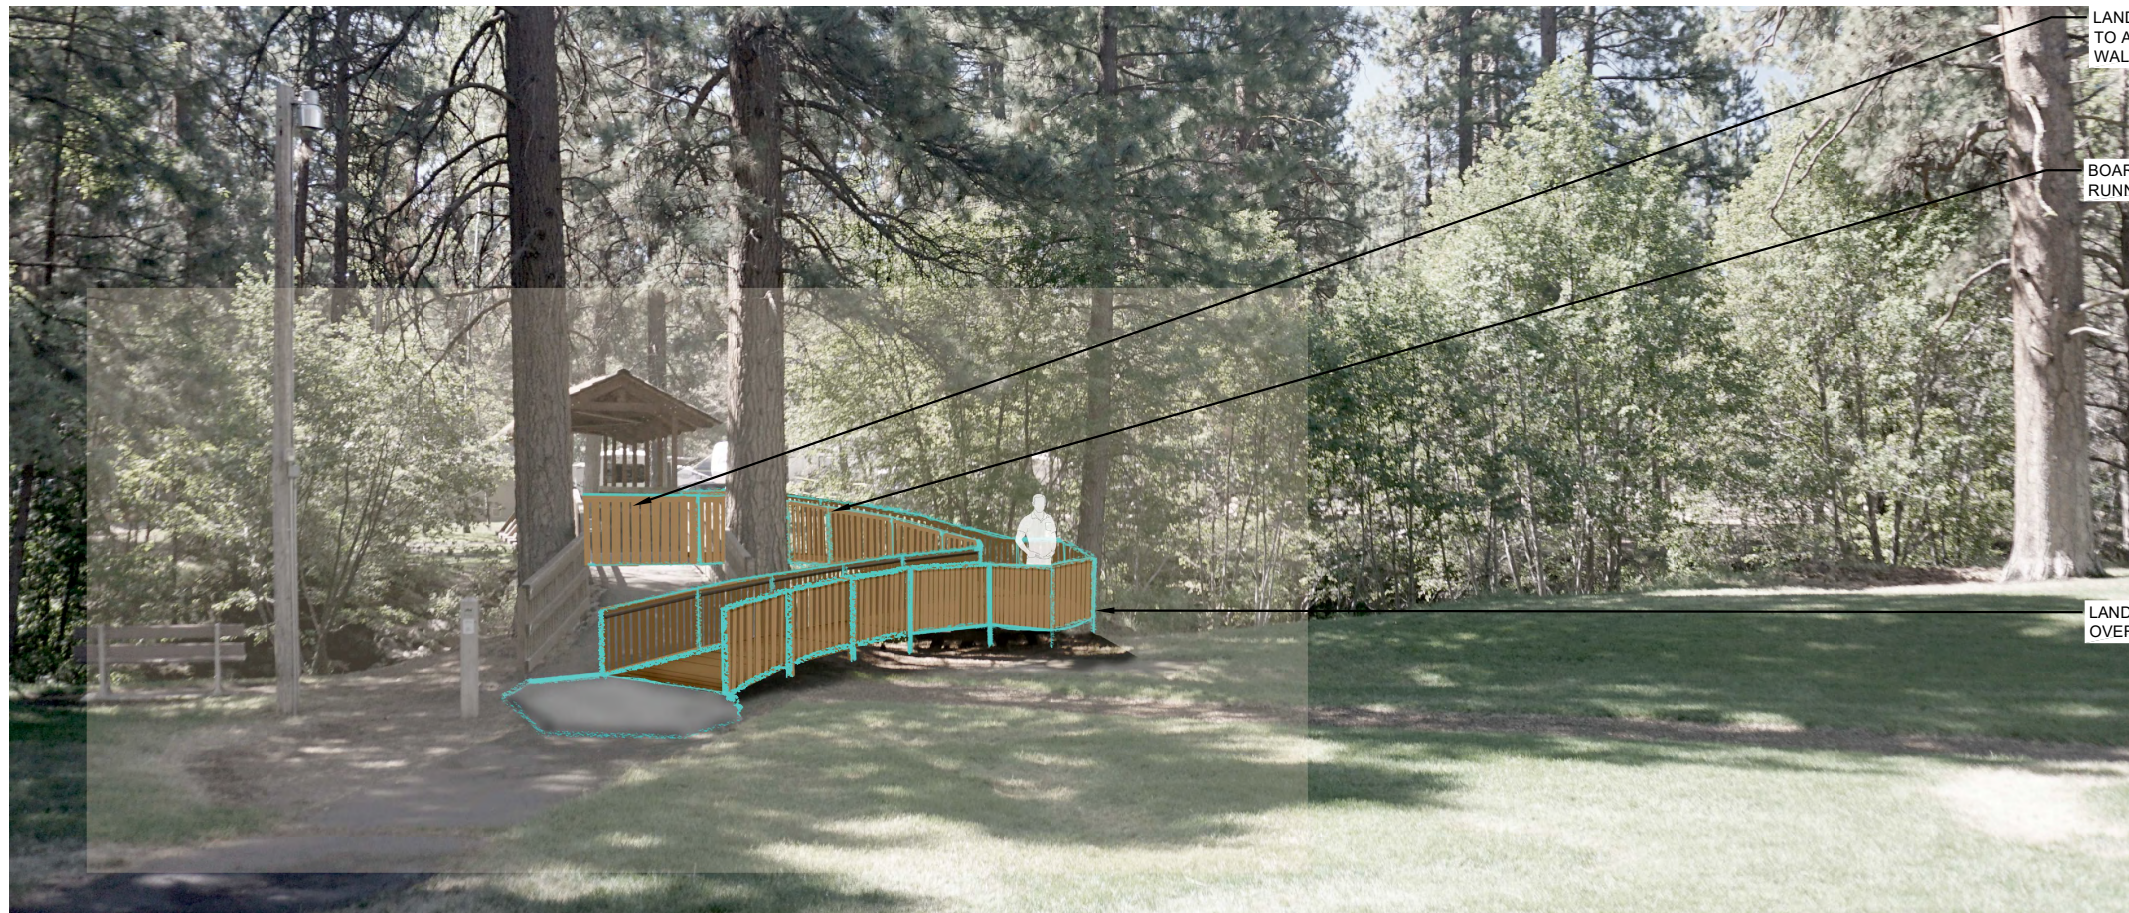
LANDING AT BRIDGE END - ELEVATED TO AVOID IMPACTS TO EXISTING WING WALLS

BOARDWALK ALIGNMENT AT ~8.0% RUNNING SLOPE WITH RAILS

LANDING AND OVERLOOK

Conceptual boardwalk alignments can be seen in the ADA Boardwalk plan sheet in Appendix A. Potential viewing platforms / creek access locations have also been included. The ADA boardwalks also provide the benefit of being able to be modified or removed later without any loss or damage to the existing structures, reducing some of the potentially required SHPO mitigation. As the design advances, SHPO representatives will determine the extent of mitigation required. Smaller impacts to the historic portions of the foot bridge will trigger smaller mitigation requirements and vice versa.

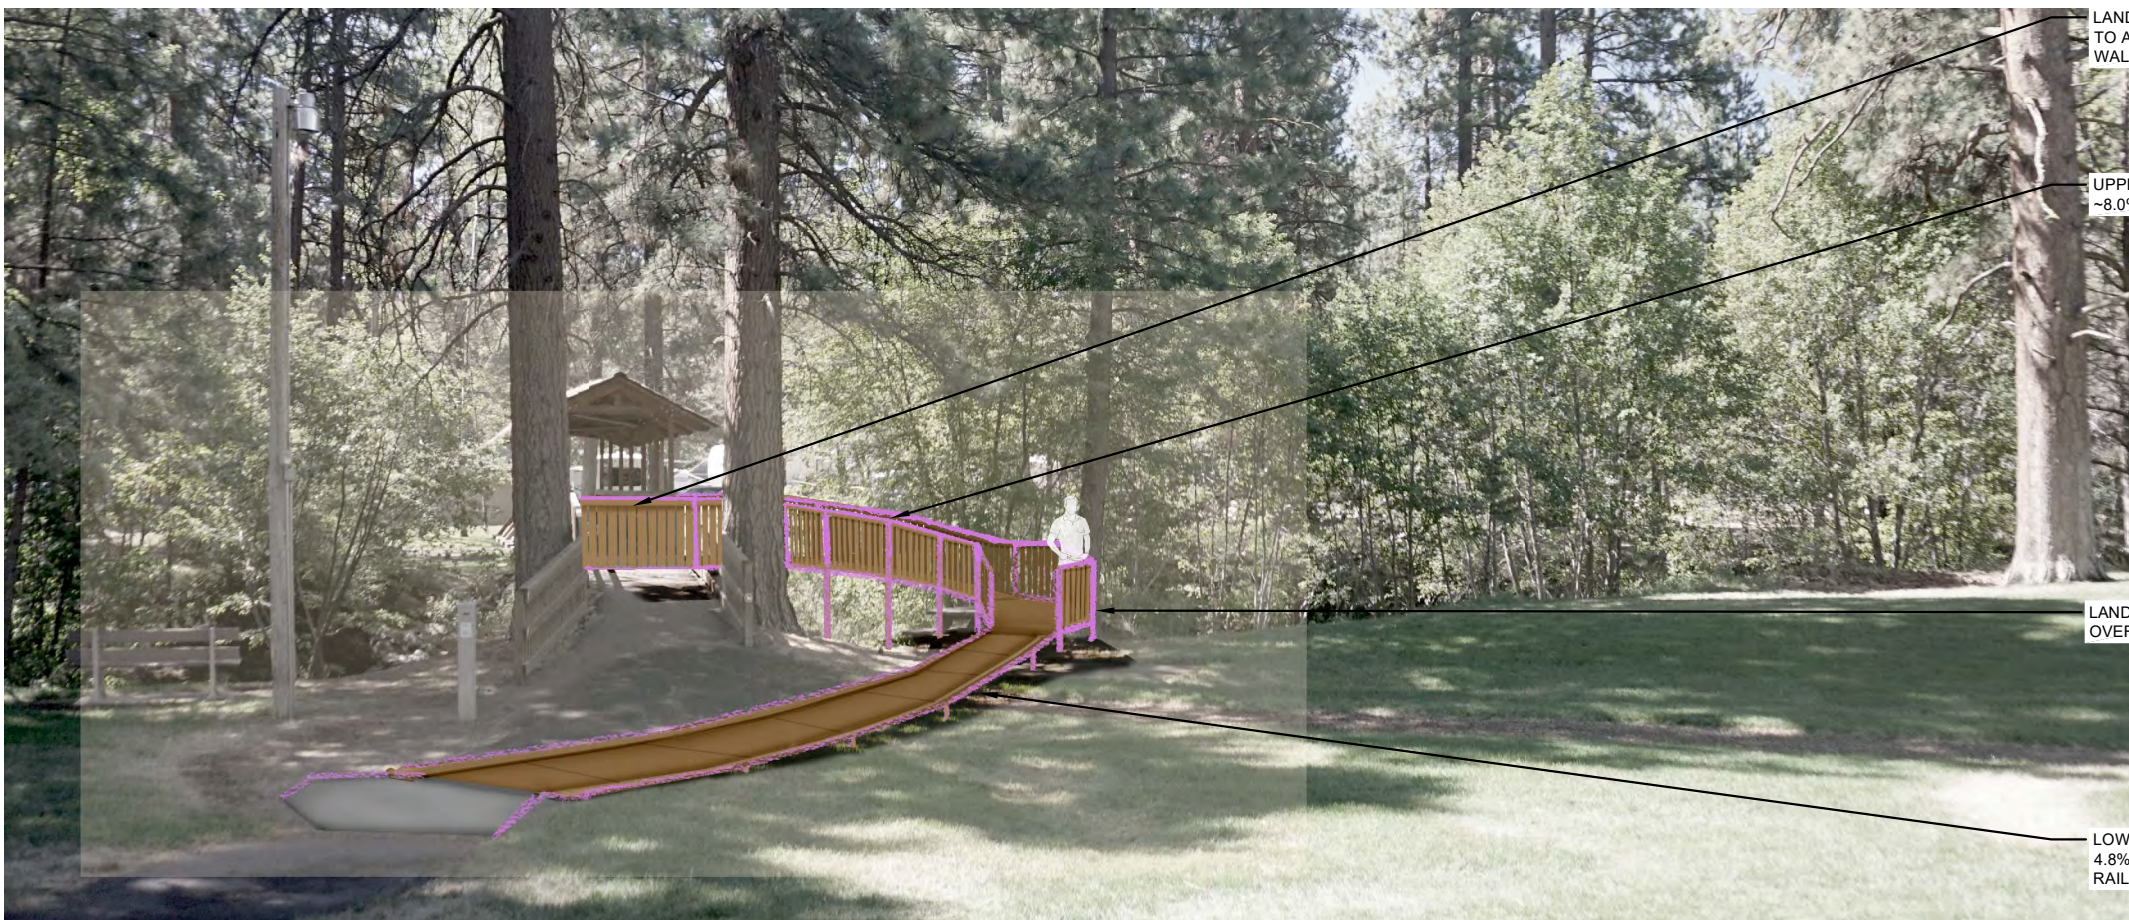
LANDING AT BRIDGE END - ELEVATED TO AVOID IMPACTS TO EXISTING WING WALLS

UPPER BOARDWALK ALIGNMENT AT ~8.0% RUNNING SLOPE WITH RAILS

LOWER BOARDWALK SECTION AT 4.8% RUNNING SLOPE WITH NO RAILS
